# **BBF3 Bekido Rate 15% Increase**

**Six Sigma Project**

**Six Sigma Black Belt Certificate**

The following document was developed at Bridgestone Neumáticos de Monterrey. It describes the application of a Six Sigma methodology to increase the efficiency of the Bead Manufacturing Line # 3, from 36% to 50%. Following the 5 phases, Define, Measure, Analyze, Improve and Control, the project accomplishes its objective, achieving the 50% Bekido Rate (cycle time efficiency) on the Bead Manufacturing Line # 3.

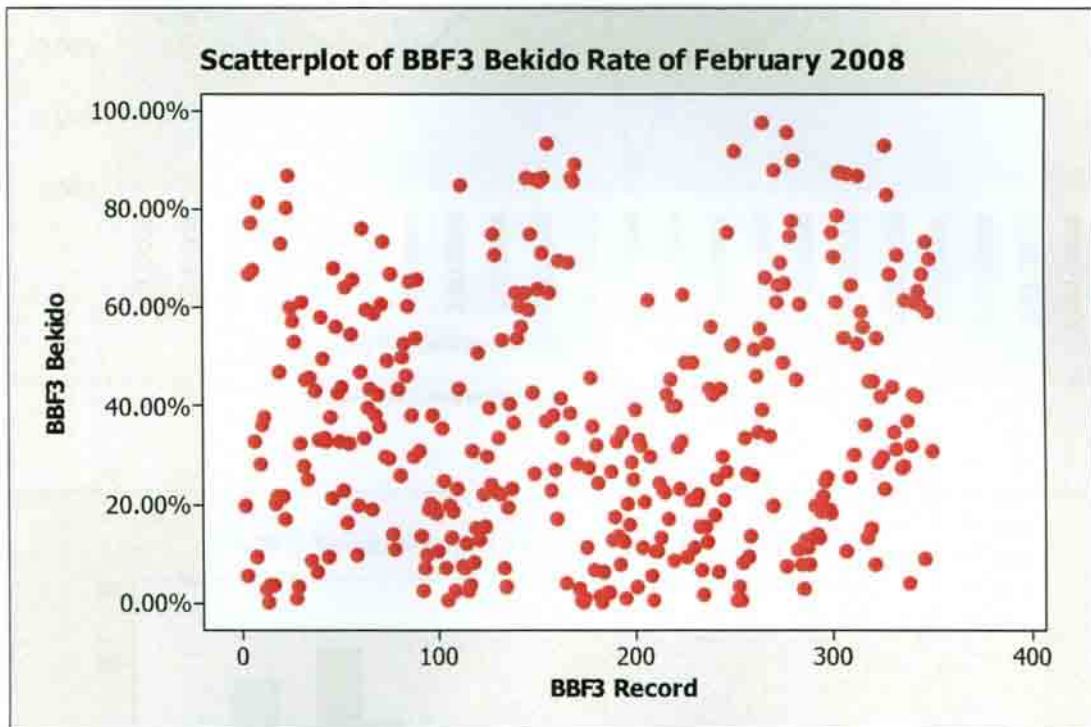
Figure 3.2-3. Scatterplot of BFF3 Bekido Rate of February 2008

The next figure shows the Bekido Rate scatter plot of all the carts manufactured on February 2008 in the BFF3.

This figure shows a significant variation in the performance of the machine from cart to cart. It was decided that the Bekido Rate records should be filtered, so we grouped the records by day and calculated the day average Bekido Rate. Next figure shows the Bekido Rate average by date vs. the target that is 50% Bekido Rate.

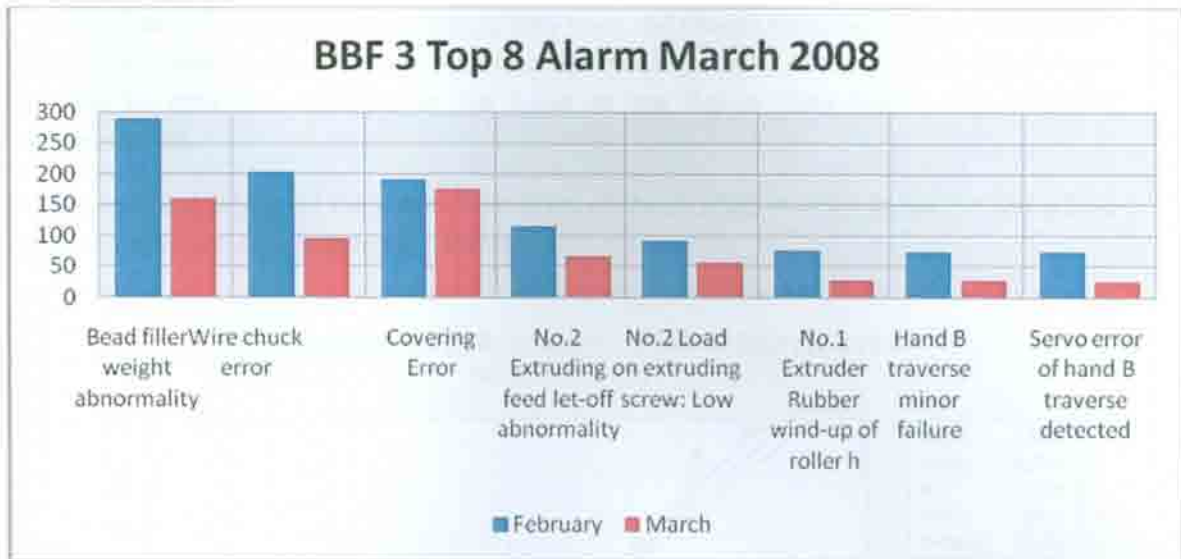
Figure 3.4-2. BBF3 Top 8 Alarm February vs. March 2008

So far, that the alarm frequency reduced from February to March. By reducing the alarm frequency it is intended to increase the Bekido Rate up to 50 %. Bekido Rate data of March 2008 was collected and filtered by day Bekido Rate average.

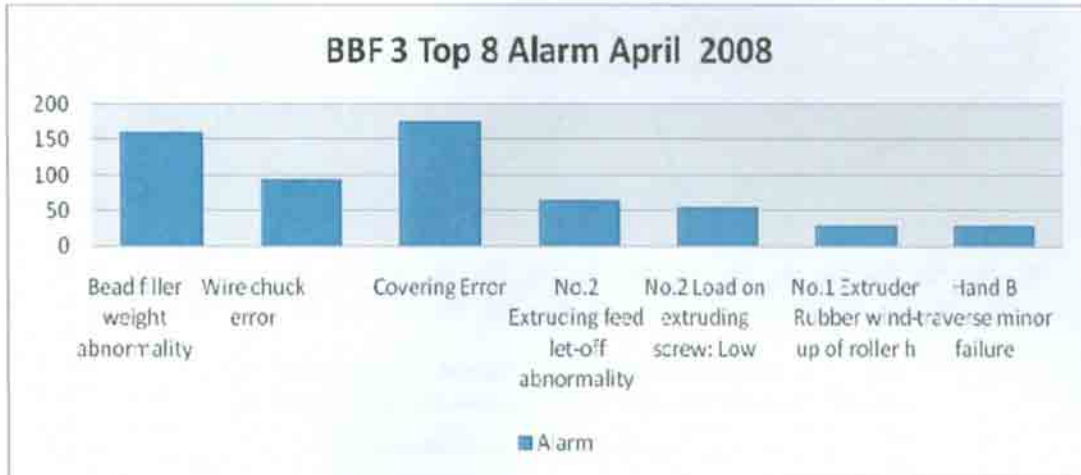
Figure 3.5-1. BBF3 Top 8 Alarm of April 2008

It has been shown that 8 alarms can represent about 15% on Bekido Rate, which is why we must closely monitor their behavior. On the next figure the alarm occurrences of the month of April 2008 are shown.

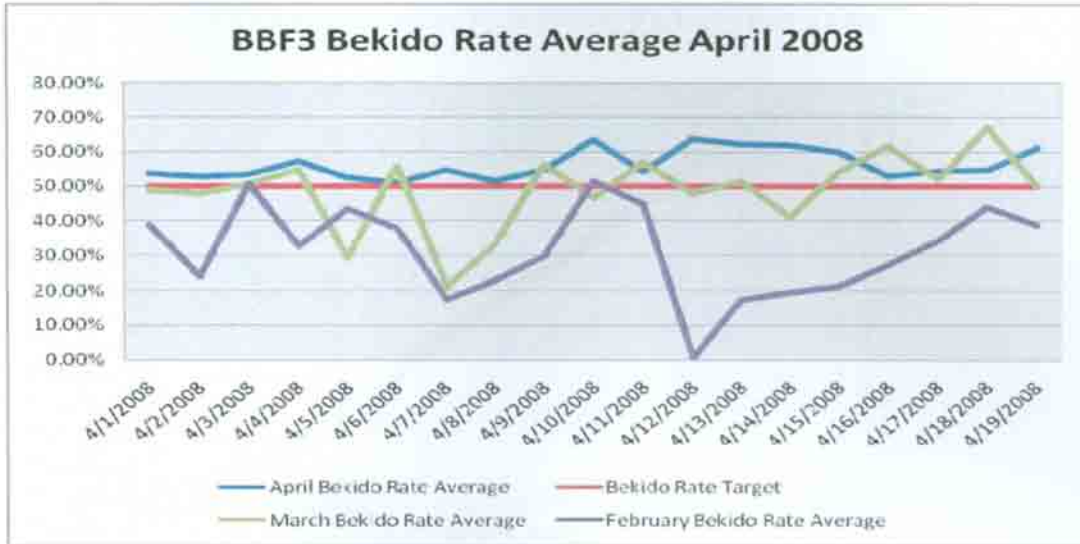
Figure 3.5-3. BBF3 Daily Bekido Rate Average of April 2008

Beside monitoring the occurrences of those 8 alarms we must monitor our main metric, the Bekido Rate. In the next figure we show the Bekido Rate obtained in April 2008.

This last figure shows that the Bekido Rate has been maintained above our target of 50%. Now lets review the progress of the Bekido Rate from the beginning of the project to the end.
